Report to the Chairman, Subcommittee
on Readiness, Committee on Armed
Services, U.S. Senate

AFLOAT PREPOSITIONING

Not All Equipment Meets the Army's Readiness Goal

B-277122

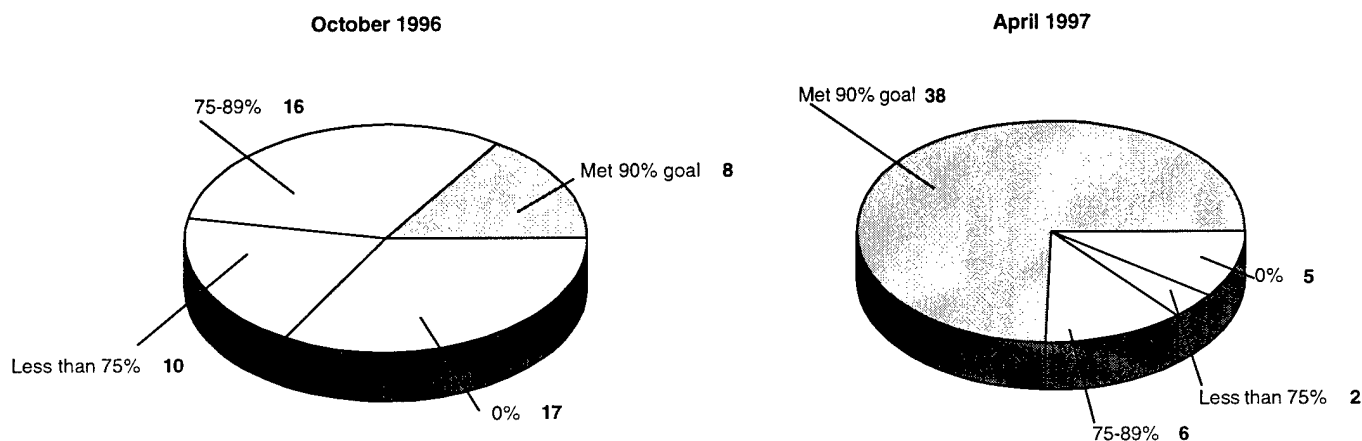
As of April 1997, 13 of the 51 unit sets of equipment that are assigned to Army prepositioning ships and considered for readiness reporting, or about 25 percent, did not meet the Army's readiness goal that 90 percent of available war reserve equipment be fully mission capable. Equipment in two unit sets was less than 75 percent fully mission capable, and five unit sets had a fully mission capable rating of zero because they did not have on hand any authorized primary weapon systems or equipment considered critical for accomplishing and sustaining a unit's mission. For example, one unit set designated to support a heavy equipment transport company did not have any of its authorized trucks or trailers.

The status of the equipment in April 1997 had significantly changed from October 1996, when 43 of the 51 unit sets did not meet the Army's goal. At that time, equipment in 10 unit sets was less than 75 percent fully mission capable, and 17 unit sets had a fully mission capable rating of zero because they did not have any of their authorized reportable equipment on hand.

Figure 1: Number of Equipment Sets That Did Not Meet the Army's Readiness Goal in October 1996 and April 1997

Note: The unit sets that had a fully mission capable rating of zero did not have any reportable equipment on hand.

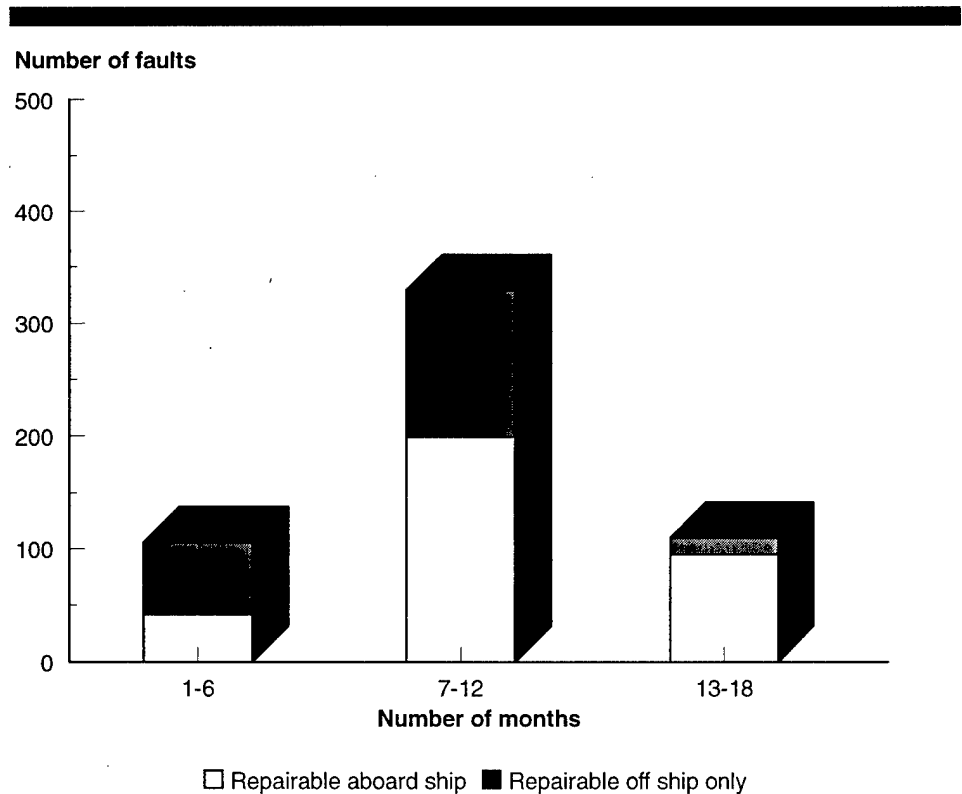
The Army's equipment status data, as of April 1997, showed that faults rendering specific pieces of equipment non-mission capable had remained uncorrected since September 1995. Figure 2 shows the amount of time that uncorrected faults have rendered equipment prepositioned afloat non-mission capable and the portion of those faults that the Army considered to be repairable while in storage aboard prepositioning ships.

Figure 2: Amount of Time That Uncorrected Faults Have Rendered Equipment Non-Mission Capable (as of Apr. 1997)

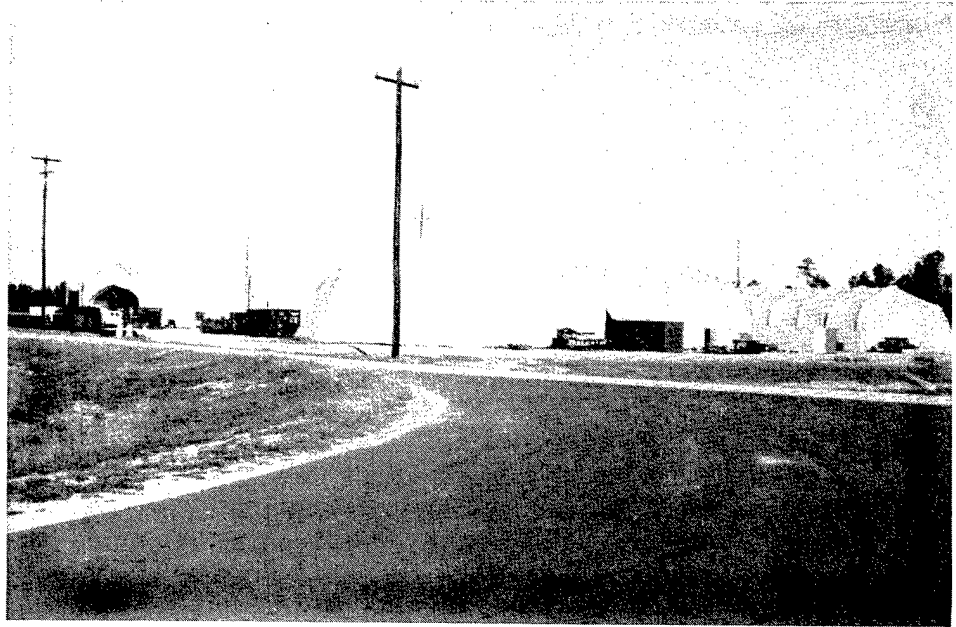
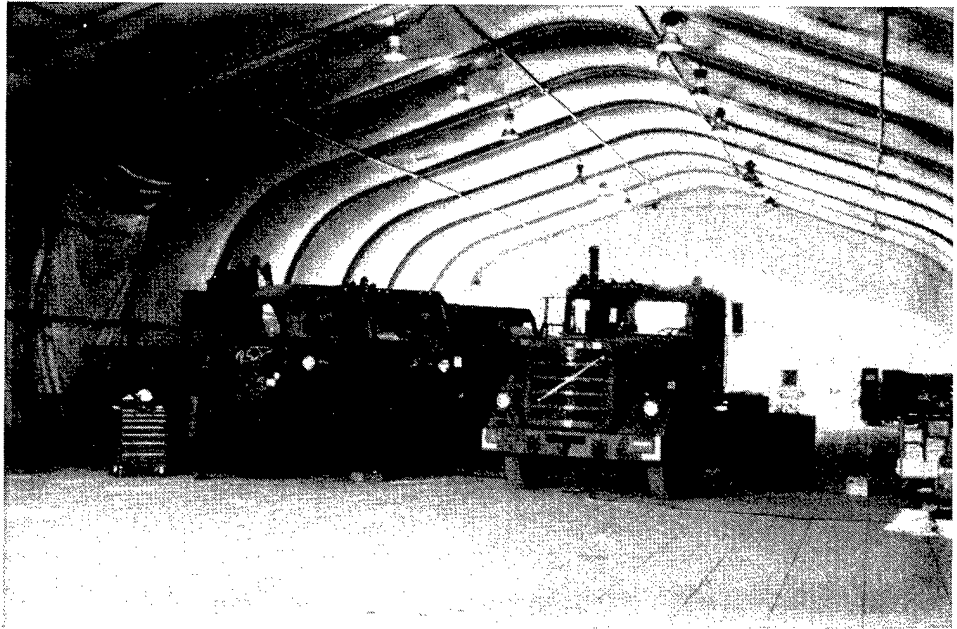
The Army received a total of \$45.7 million in fiscal year 1995 and 1996 appropriations for construction of a maintenance facility at Charleston, South Carolina. The site preparation and the initial phase of construction were originally scheduled to be completed before October 1996—in time for the facilities to be used to conduct maintenance on the first full shipload of the brigade set of equipment, which is prepositioned afloat. However, contractors did not complete scheduled construction and renovation projects in time. As a result, the maintenance contractor had to continue to rely on temporary shelters instead (see fig. 3) and had to develop less efficient maintenance processes.

Figure 3: Temporary Maintenance Shelters at the Charleston, South Carolina, Site

According to Army officials, the construction delays were primarily due to poor soil conditions and the removal of unanticipated hazardous waste, such as asbestos and pigeon droppings, from existing structures.⁹ The officials said that the continued reliance on temporary maintenance facilities did not delay the successful upload of fully mission capable equipment. They also said that the only discernable impact of these less efficient working conditions was a slight but unquantifiable increase in the amount of overtime charged to the contract. The Army plans to complete the transition of maintenance operations from the temporary shelters to the permanent facilities in fall 1997. In accordance with the original facility funding plan, the Army requested \$7.7 million in fiscal year 1998 for further construction at the site, making the total estimated cost for the facility \$53.4 million.
